Dallas/Fort Worth Airport Train Critical Needs

John C. Graddy, P.E.

**Senior Engineer, Lea+Elliott, Inc., 1009 West Randol Mill Road,
Arlington, Texas 76012; PH 817-261-1446; jgraddy@leaelliott.com**

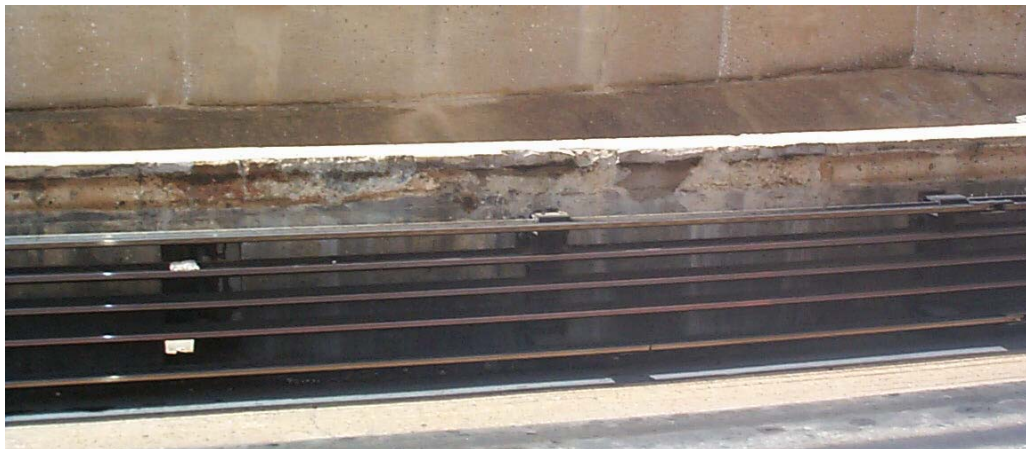
Airport Train Maintenance personnel had performed many different types of repairs to address this persistent problem, but no suitable repair had been found. Fast setting repair mortars were spread in thin layers over degraded sections of wall and small portions of wall had been sawn out and patched with similar repair mortars to cover areas where the degradation became severe. These repairs began to crack, spall and deteriorate over time. Once minor spalls developed, entire patches deteriorated due to guide wheels pounding over repaired surfaces. Degradation of the walls and of previous repairs is shown in **Figure 1**. As shown in the figure, neither of these previous repairs proved to be durable.

Other repairs had also been tried in the past. Thin, flexible plastic sheets were glued to sections of degraded wall. These sheets wore out or fell off. Epoxies were applied to the surfaces and they quickly cracked and delaminated. Thin, stainless steel plates were attached to the tops of walls in severely degraded sections using countersunk screws. These warped and cracked and also proved to be an inappropriate repair.

Figure 1: Previous parapet wall running surface repairs.

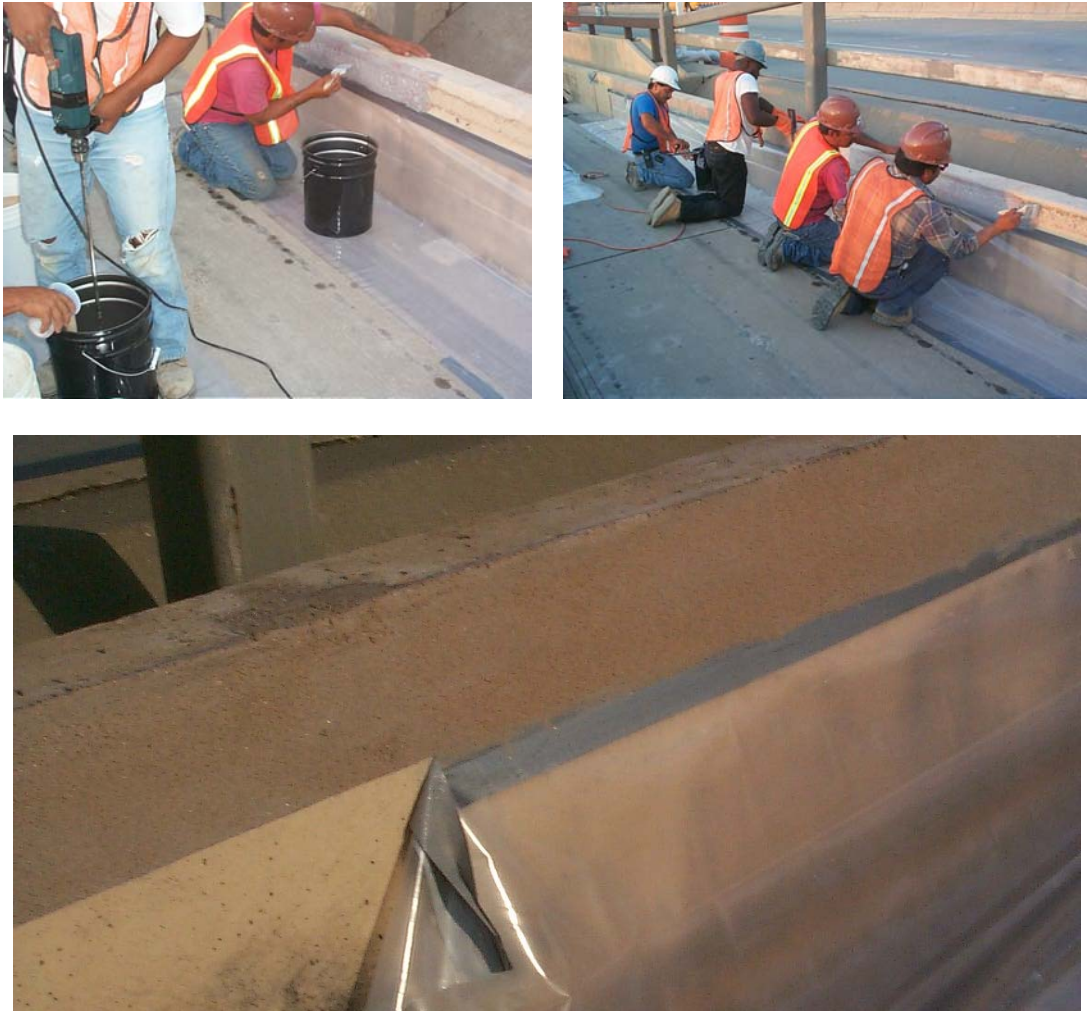
Figure 2: Epoxy-sand grout being applied to parapet wall running surface.

Trial batches of epoxy-sand grout were mixed and applied to unused sections of guideway located in the Airport Train maintenance area to test design assumptions. Surface preparation included grinding any exposed steel to a shiny metal condition and pressure washing with water to remove loose particles and bond-inhibiting substances. After surfaces were allowed to dry overnight, sheet plastic was used to mask off areas below the bottom of the surfaces to be repaired and to protect power and signal rails during the work. Surfaces were then primed with straight epoxy by brushing and stippling, taking care to fill all pores of the concrete surface. Immediately following the prime coat, epoxy-sand grout was troweled onto the walls keeping the total grout thickness as thin as possible. It was required that epoxy-sand grout be applied to the primed surface before the primer “skinned over” and the work was also being done during the heat of mid-summer to minimize the required cure time. This required workers applying grout to lag behind those applying primer by only a few feet. When the grout was troweled onto the primed surface, it forced some of the prime coat deeper into cracks in the wall while at the same time absorbing some of the prime coat into the stiff grout. The appropriate epoxy/sand ratio was established by the contractor as that which could be applied most effectively, and this was established by trial applications. Grout was cured for about 30 minutes before masking was removed.

The first trial applications revealed that the disproportionately large sand particles in the approved sand were problematic. They tended to gouge and streak the surface of the grout as it was being applied and generally made it more difficult to apply than expected. After discussing the results with the contractor it was decided to try the somewhat gap-graded sand and the entire process was repeated the following day. The gap graded sand, with its generally smaller particles, proved to be much more

workable and was used in the Pilot Program applications. This exercise was invaluable in finalizing the grout mix materials and proportions and in proving the mix and application assumptions. It also familiarized the contractor and observing maintenance personnel with the entire process and prepared them for the final applications. **Figure 2** shows the epoxy-sand grout being applied to a section of parapet wall.

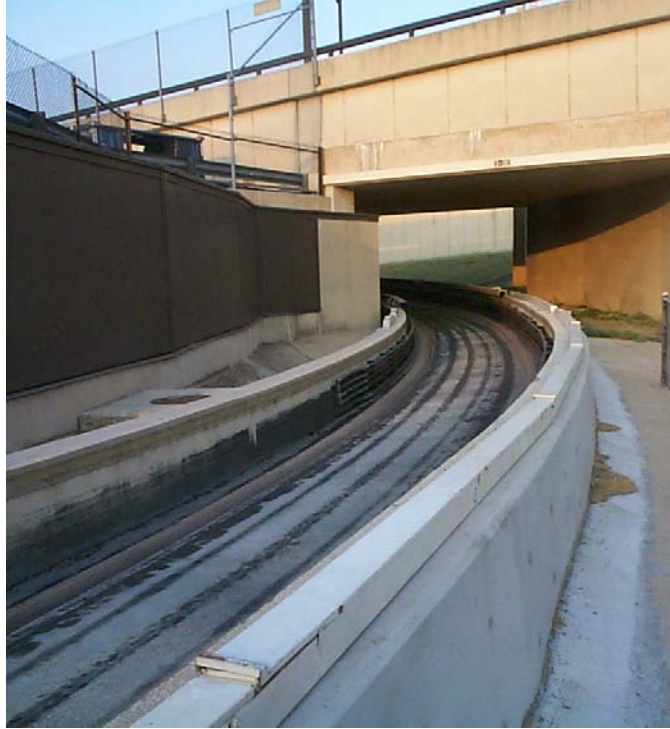
Contrary to the goal of performing epoxy-grout running surface repairs during summer months to minimize cure time, two of the Pilot Program locations were repaired during January. These locations were in a guideway section critical to Airline Operations that also required more substantial parapet wall repair and strengthening. This work required a two-day shutdown to complete and the construction schedule and shutdown dates were closely coordinated with the affected airline to minimize the impact to airline passengers. Enclosing the entire length of on-grade guideway in a plastic bubble and heating the air with kerosene heaters minimized the cure time required for the epoxy repairs, as well as for concrete placed to accommodate the repair and strengthening of the wall. This section of repaired parapet wall running surface is shown on the left-hand side of **Figure 3**. A close-up view of another repaired section is shown in **Figure 4**.

Figure 3: Parapet wall running surface repaired with epoxy-sand grout.

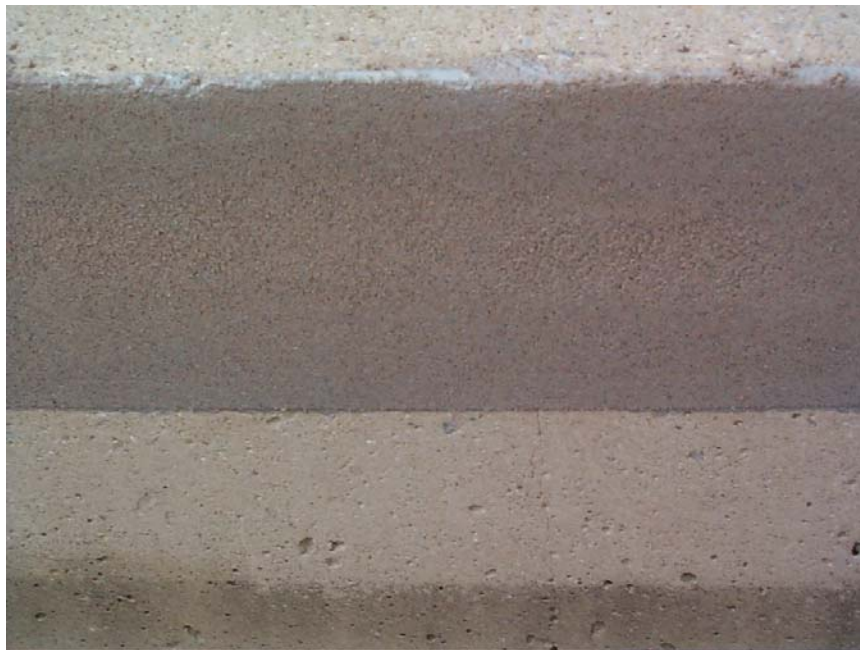
Figure 4: Close-up of epoxy-sand grout repair.

with this repair and consequently, evidence of curling or delamination of the epoxy-grout from the concrete surface would be considered a failure. Airport Train maintenance personnel, designers and other interested parties have monitored the repairs periodically since they were implemented. As of this date, no significant degradation of the repaired surfaces has been observed. Some gouging of repaired surfaces has been observed, but this was attributed to an excessively worn vehicle guide wheel. This repair has been recommended to be implemented throughout the guideway system.
